KERR WOOD LEIDAL  
consulting engineers

# Rainwater BMP Review

## Appendix A – BMP Review

### A.2 5<sup>th</sup> Street Complete Street Rain Gardens

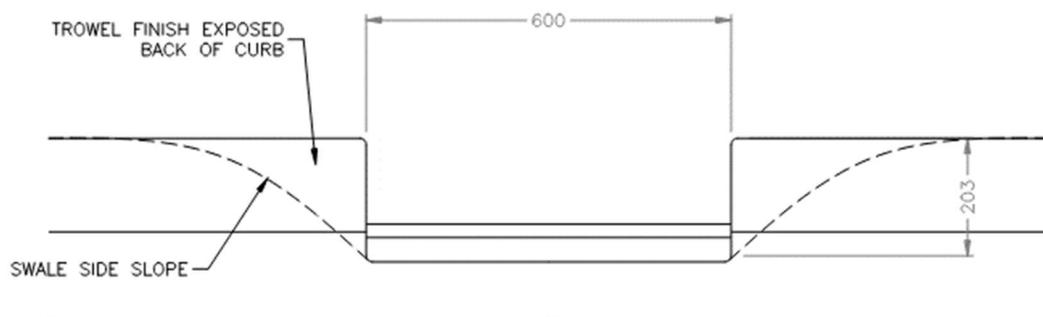
1. Flow enters the rain garden through a curb cut that is located facing (just opposite of) either a sediment basin or a lawn drain and is connected to the outlet by a concrete swale. While it appears the intent of the concrete pad and directly connected sediment basin is to efficiently handle sediment for ease of maintenance removal, this design short circuits the rain garden such that flow goes from the curb cut to the outlet without ever entering the planted portion of the rain garden. This reduces the opportunity for infiltration of runoff and prevents treatment of runoff through the growing medium soil;

2. The rain garden outlets, both sediment basins and lawn basins, are located at the low points of the rain garden, so that runoff does not have an opportunity to flow into the remainder of the rain garden;

3. The lawn basin outlets are located below the surface elevation of the growing media; therefore, no water can pond in the rain garden in order to promote infiltration during high intensity events; and

4. It appears the grading of the surface of the rain garden is raised above the elevation of the curb cuts so that the flow that enters the curb cuts is confined to the concrete swale and has no opportunity to spread to the sides and flow into the rain garden from the curb cut inlet (see detail below):

1. Overflow outlets should be located as far as possible from runoff inlets to maximize residence time and treatment within the rain garden. The curb cut inlets should not lead directly to any lawn basins;
2. The lawn basin outlets should be raised above the rain garden surface so that ponding and infiltration through the growing media occurs before overflow to the storm drain system; and
3. There should be a depth of ponding available above the surface of the growing medium for water to pond in the rain garden before water backs up into the street. The surface of the rain garden area should be lower in order to allow ponding.

1. Adding risers to the lawn basin outlets to prevent inflow until the water in the rain garden has ponded to the elevation of the curb cut. The same could be done with the sediment basins, but this would prevent the sediment basins from functioning as intended; and
2. Removing the top centimeters of the growing medium and mulch in the centre of the rain garden and reducing the level of the growing medium surface to form a swale in the growing medium which would allow runoff to flow to the planted areas from the concrete pads at the curb cut inlets. This would require re-planting the plants in the rain gardens where the surface material is removed.
